PROTECTION OF MOORING BUOYS  
PART IX. RESULTS OF EIGHTH  
RATING INSPECTION

June 1967

NAVAL FACILITIES ENGINEERING COMMAND

Technical Report R-531

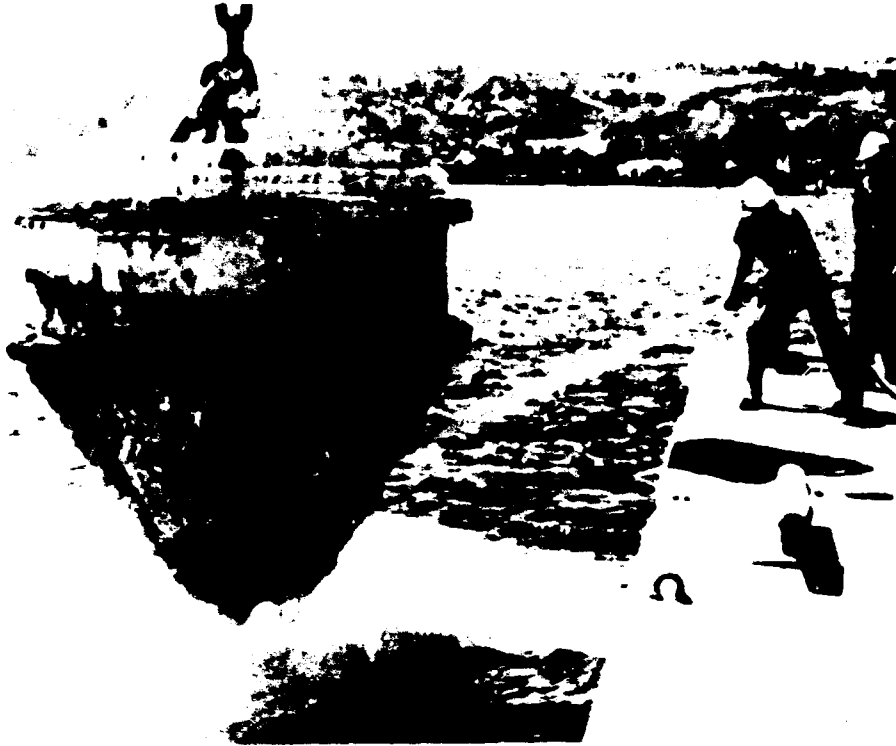
The condition of the System 1 buoy (Figure 1) had not changed much since the previous rating inspection. The slight pinpoint rusting on the buoy, especially in the splash zone, may have been initiated by the small blisters previously noted there.

The many patches of underwater-curing epoxy,<sup>10</sup> most of which had been applied 3-1/2 years earlier to underwater areas damaged by the impact of moored vessels, were still adhering tightly to the underlying steel and providing good protection from corrosion despite the previously reported<sup>3-8</sup> lifting of the edges of some of these patches where they extended over weathered coating.

Figure 1. Hosing off System 1 buoy.

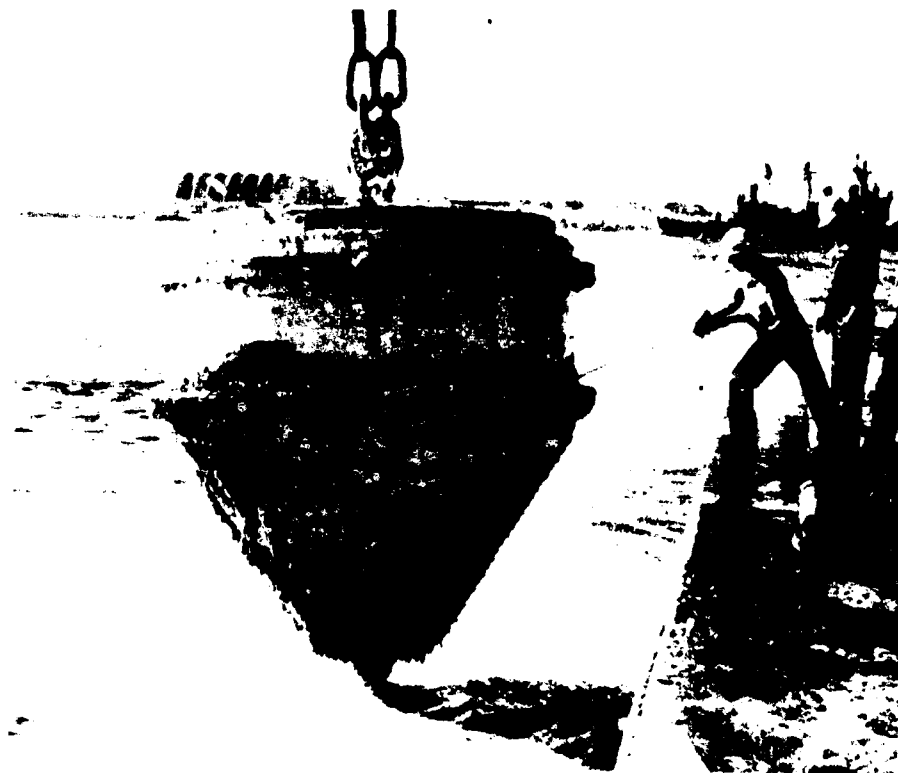
The condition of the System 2 buoy (Figure 3) was essentially unchanged since the last inspection. The two areas where impact damage to the coating had been patched with underwater-curing epoxy 1 year earlier<sup>7,8</sup> were receiving full protection from these patches (Figure 4). Aside from the previously noted<sup>5</sup> areas of slight corrosion caused by abrasion, System 2 was providing good protection. A few of the rivet heads in the submerged zone of this Mark I buoy had some galvanic corrosion where paint had been removed by abrasion.

Figure 3. Hosing off System 2 buoy.

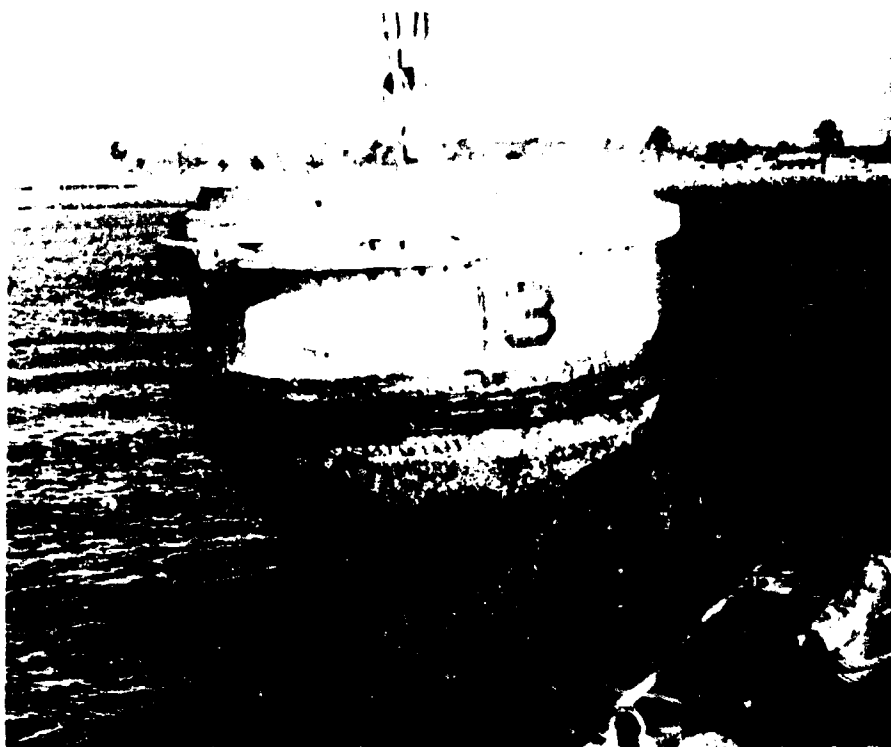
The condition of the System 3 buoy (Figure 5) was essentially unchanged from that noted at the last inspection. The epoxy primer exposed in the submerged zone where much of the polyester topcoating had delaminated was continuing to protect the underlying steel. The rusting in all three zones was related to abrasion damage. As noted on the previous Mark I buoy (System 2), there were in the submerged zone a few rivet heads undergoing galvanic corrosion initiated by abrasion of the coating.

Figure 5. System 3 buoy after removal of fouling.

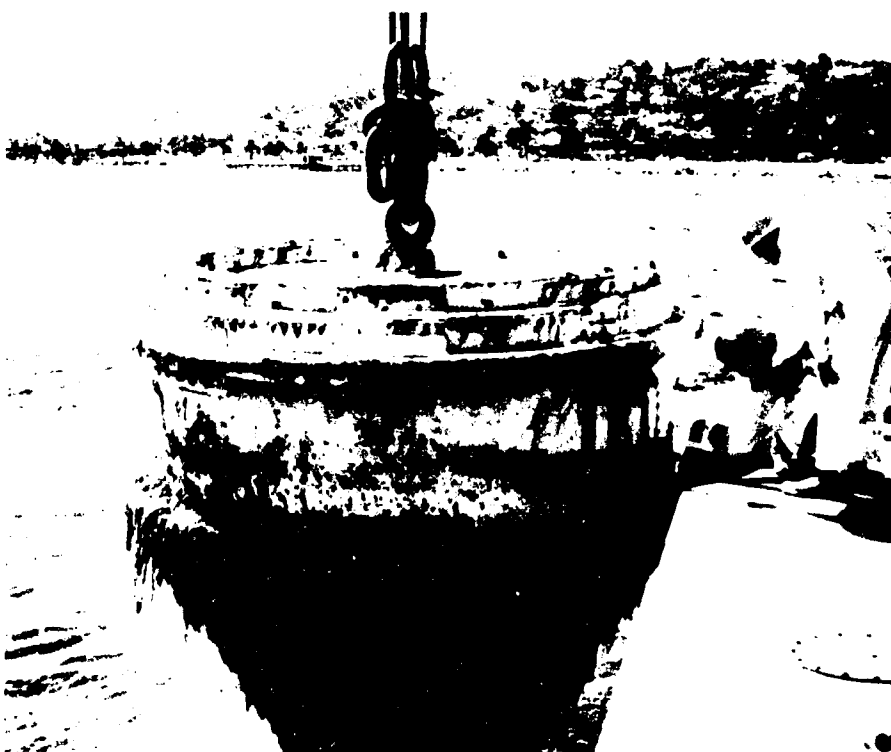
The condition of the System 5 buoy (Figure 6) was essentially unchanged since the last inspection. Most of the coating damage was related to abrasion. Abrasion had initiated galvanic corrosion of some rivet heads in the submerged zone, as had occurred on most of the other Mark I buoys.

Figure 6. Determining chalking on System 5 buoy before hosing off fouling.

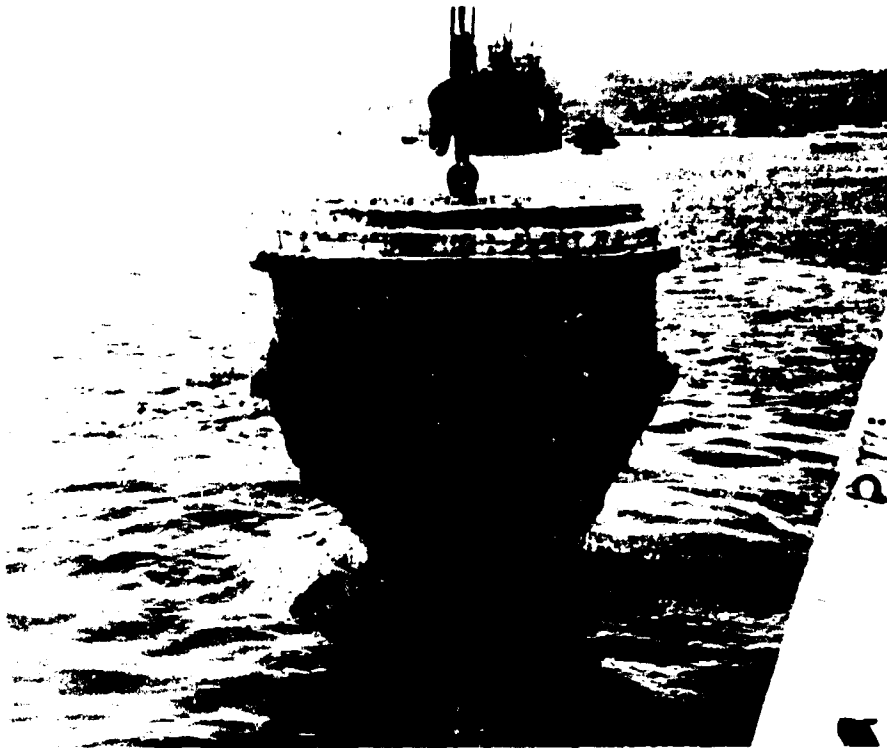
Systems 6 and 6C were identical, but the 6C coating was applied to a cathodically protected buoy. The condition of both buoys (Figure 7) was essentially unchanged since the last inspection. The deterioration on each was largely a result of abrasion damage, and the better condition of the System 6C buoy is a result of the cathodic protection and the heavier fendering.

Figure 7. System 6 buoy before removal of fouling.

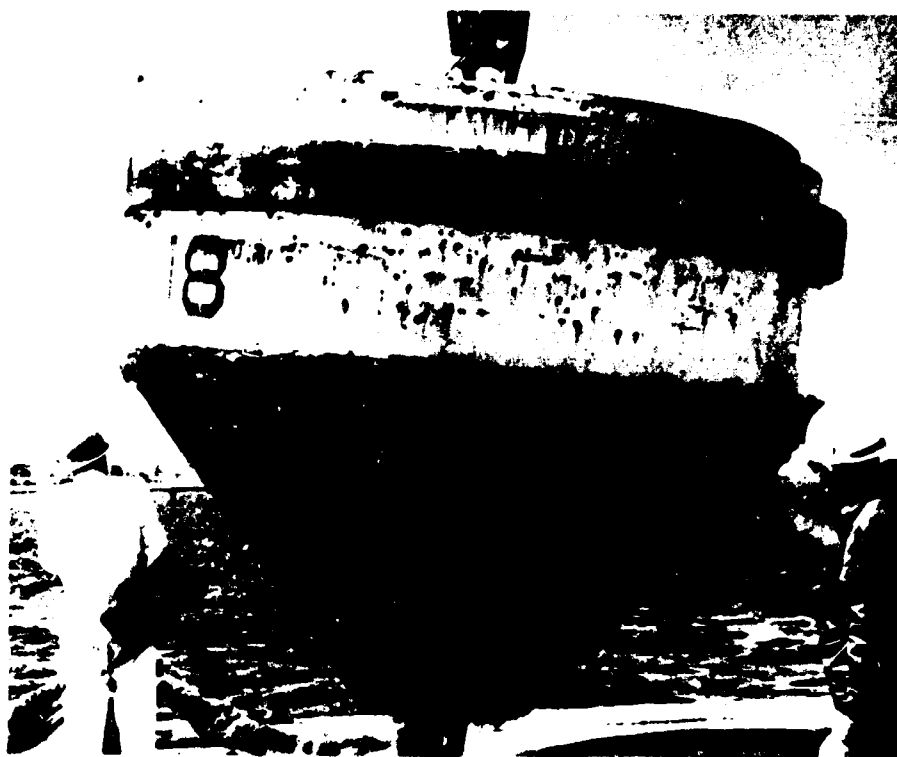
The condition of the System 8 buoy (Figure 8) had not changed appreciably since the last inspection. The submerged portion of this buoy had the identical coating system used on the System 7C buoy, and consequently, the condition of the coating system in this area on both of these buoys was quite similar. There was, however, more rusting in this area of the System 8 buoy, since it did not receive cathodic protection. Rusting on the side of the buoy was either of the pinpoint variety or had been caused by abrasion.

Figure 8. System 8 buoy after removal of fouling.

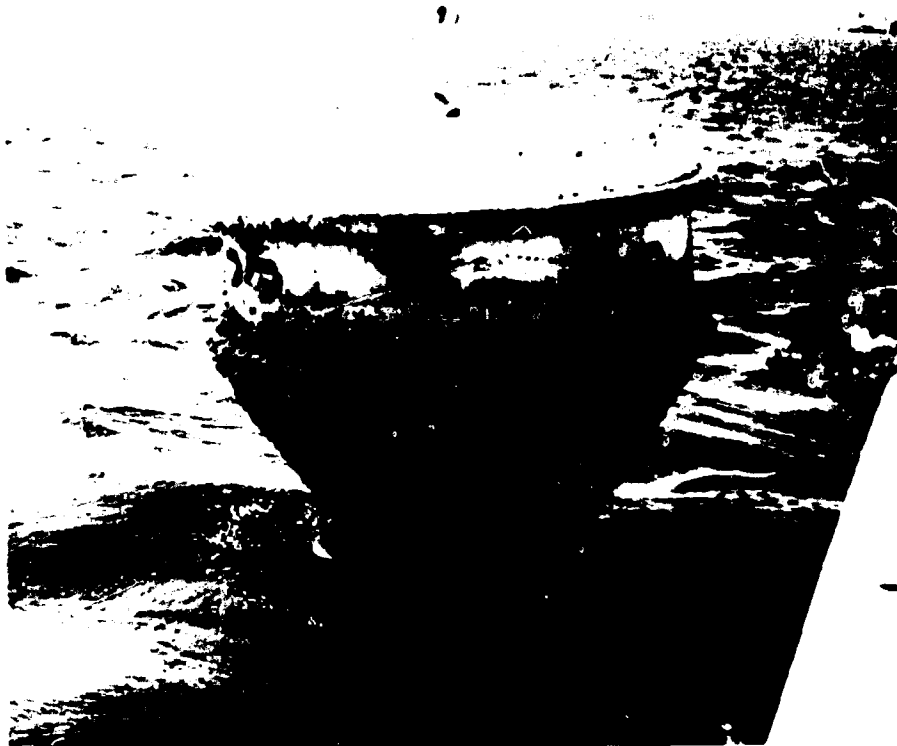
The condition of the System 9 buoy (Figure 9) had changed very little since the last inspection. The coating on the side and underwater portions of the buoy had been damaged 1 year previously, probably by abrasion. The underwater-curing epoxy patches applied to these areas at that time, as well as three smaller ones applied 6 months later, were all in good condition and protecting the underlying steel. About eight additional small damaged spots on the underwater portion were now in evidence. It appeared that these were areas that had been damaged 1 year earlier, but were too small to require patching until undercutting of the vinyl system had enlarged them to their present size. These were cleaned and patched with underwater-curing epoxy in the manner previously used.<sup>7,8</sup> The type and amount of fouling on this buoy were similar to those on test buoys without an antifouling coating.

Figure 9. System 9 buoy after removal of fouling.

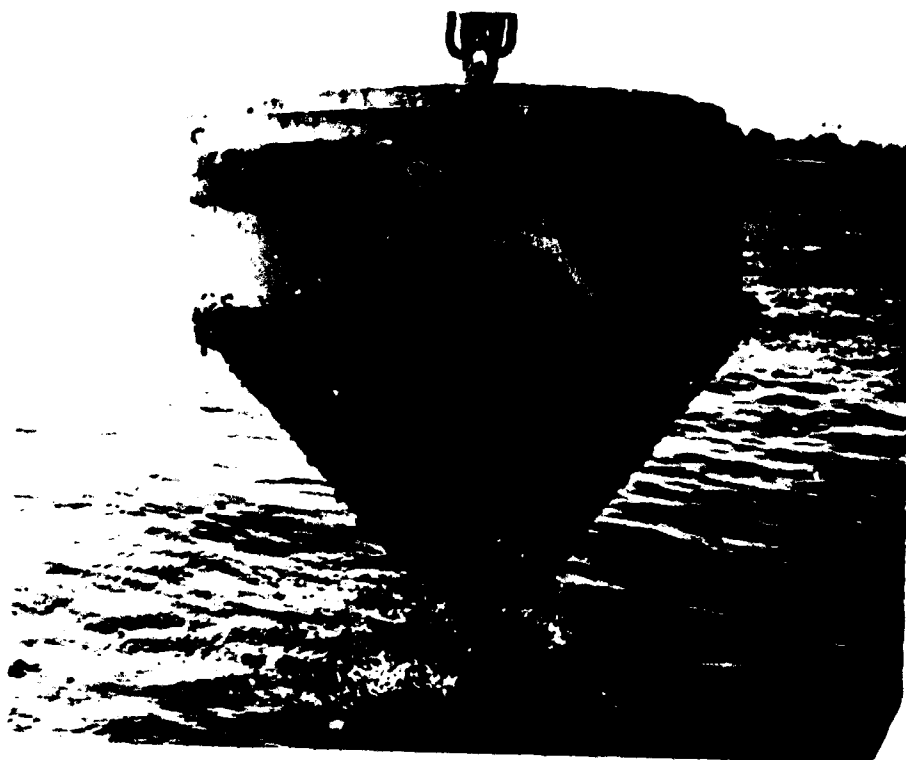
The condition of the coating on both buoys had not changed much since the last inspection. Most rusting was due to abrasion or was of the pinpoint variety. The System 13C buoy (Figure 11) was free of rusting in the submerged zone because of its cathodic protection. The square of bare steel previously exposed on the cone of this buoy was also free of rust but had some barnacle fouling.

Figure 11. System 13C buoy after removal of fouling.
